MISCELLANEOUS PAPER C-69-6

# CONCRETE CORES FROM DRY DOCK NO. 2 CHARLESTON NAVAL SHIPYARD, S. C.

June 1969

Southeast Division  
Bureau of Yards and Docks  
U. S. Navy

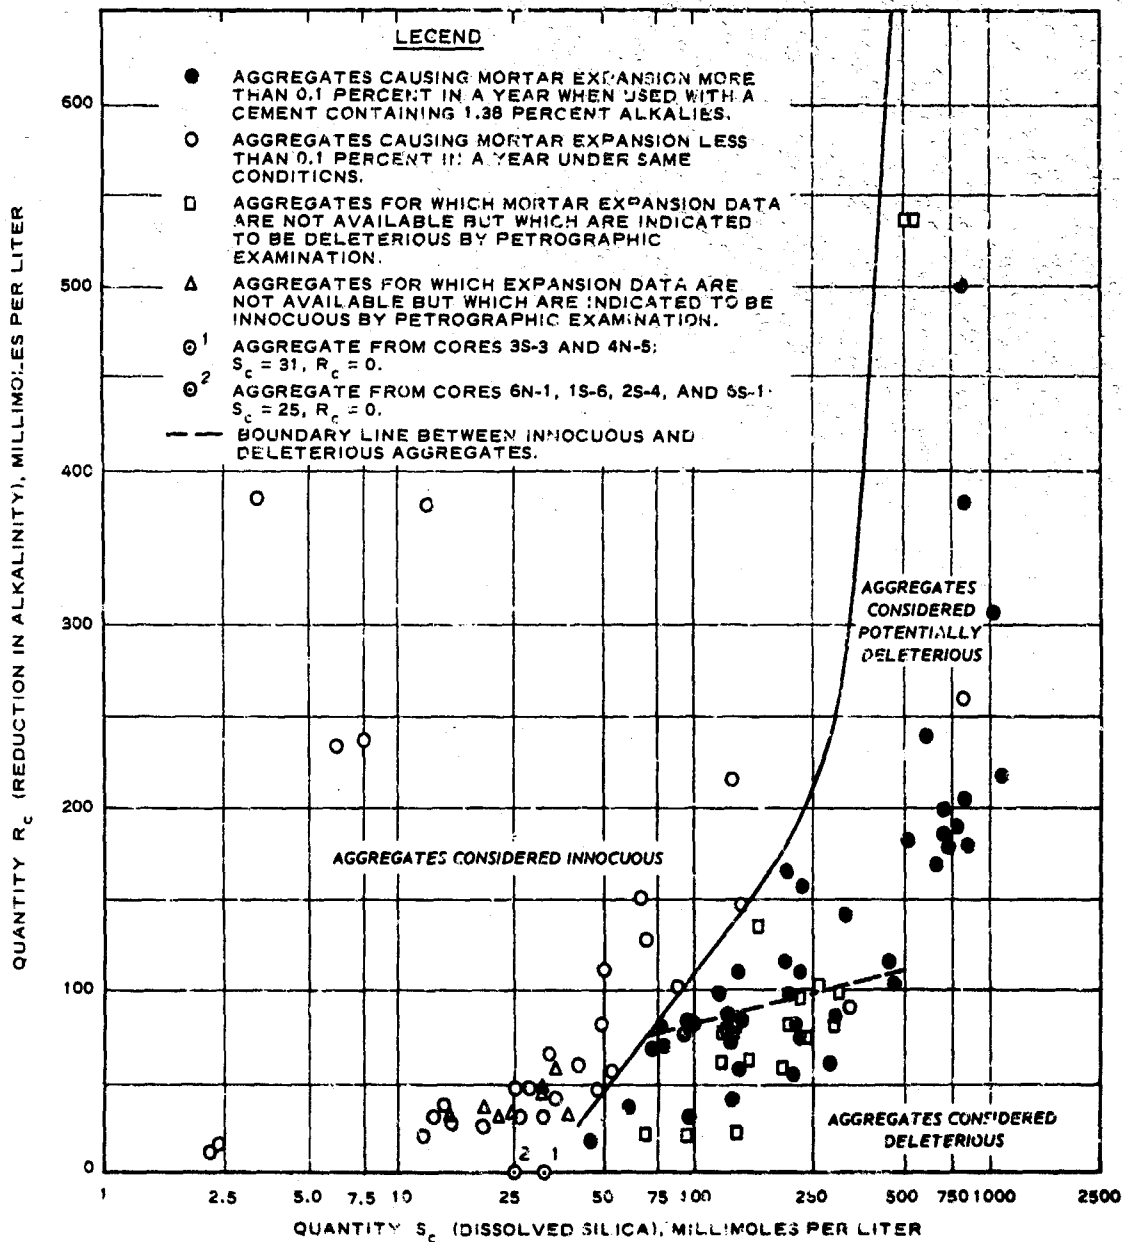
30. The results of the quick chemical test, shown in fig. 5, do not indicate a potentially reactive aggregate. These results are discussed in Progress Report 2 (Appendix B).

Fig. 5. Results of quick chemical test (CRD-C 128, ASTM C 289)<sup>1</sup> on coarse aggregate from six concrete cores from Dry Dock No. 2

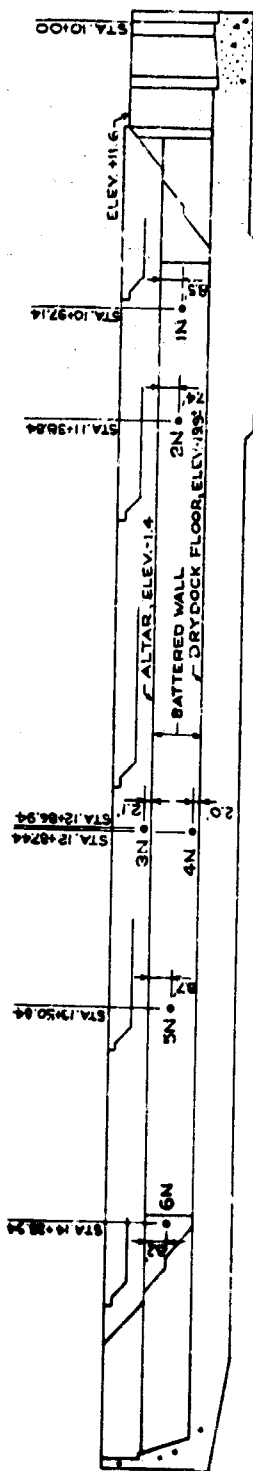
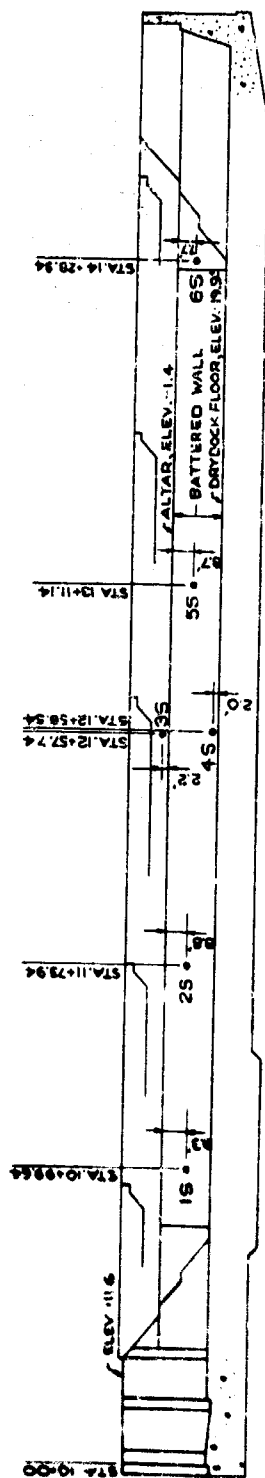
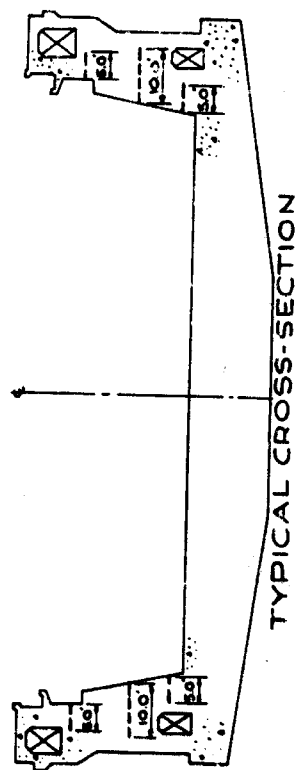
ELEVATION - NORTH WALL

ELEVATION - SOUTH WALL

TYPICAL CROSS-SECTION

CONCRETE CORE BORINGS  
ARE SHOWN THUS. 2N6

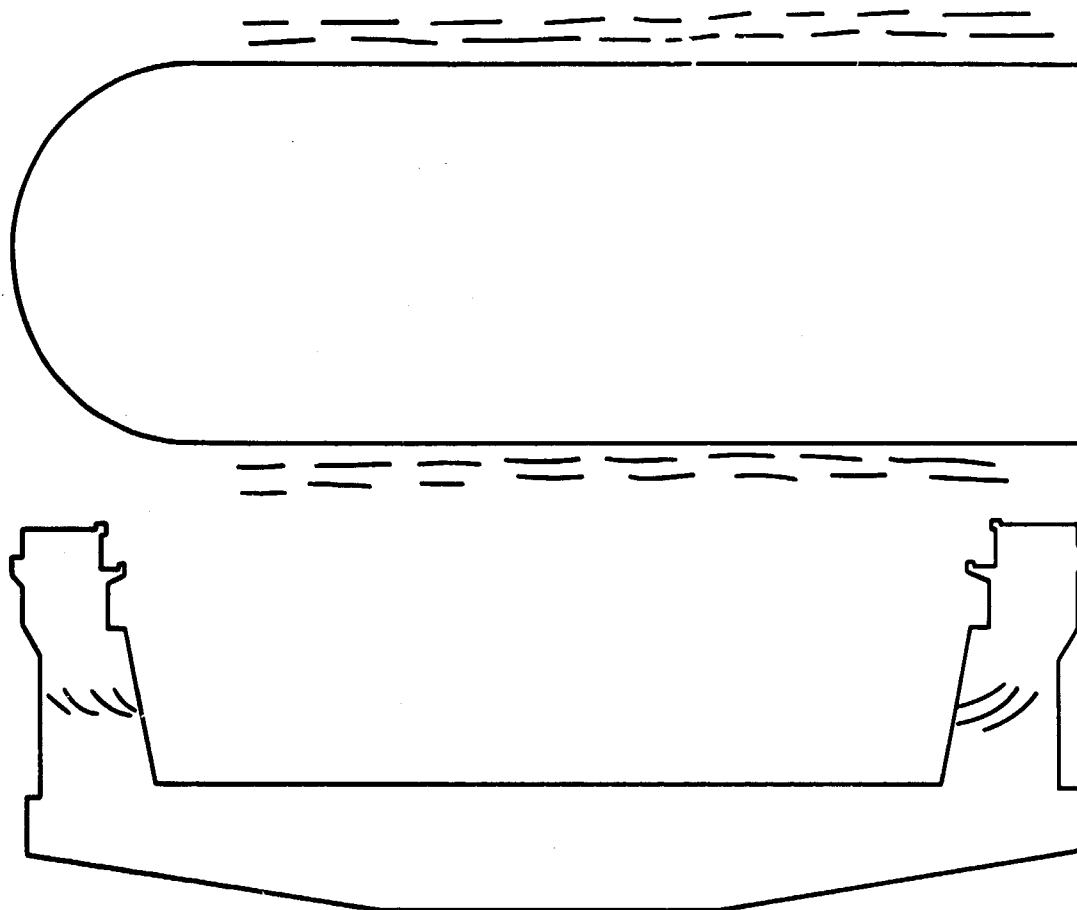
7. The damaged cores were oriented as they were originally located in the structure, and general direction of elongation and inclination of the major crack planes were determined (fig. B1). If it is assumed that the concrete expanded toward the free side and consequently cracked normal to the available expansion direction, a crack pattern like the one shown would be produced. Only trends are shown in the figure; the extent in length or in depth in the wall of the crack system is not known.

Fig. B1. Sketch plan and cross section, Dry Dock No. 2, showing directions of elongation and inclination of major crack systems in damaged cores. The sketch indicates only direction and inclination, not extent or distribution

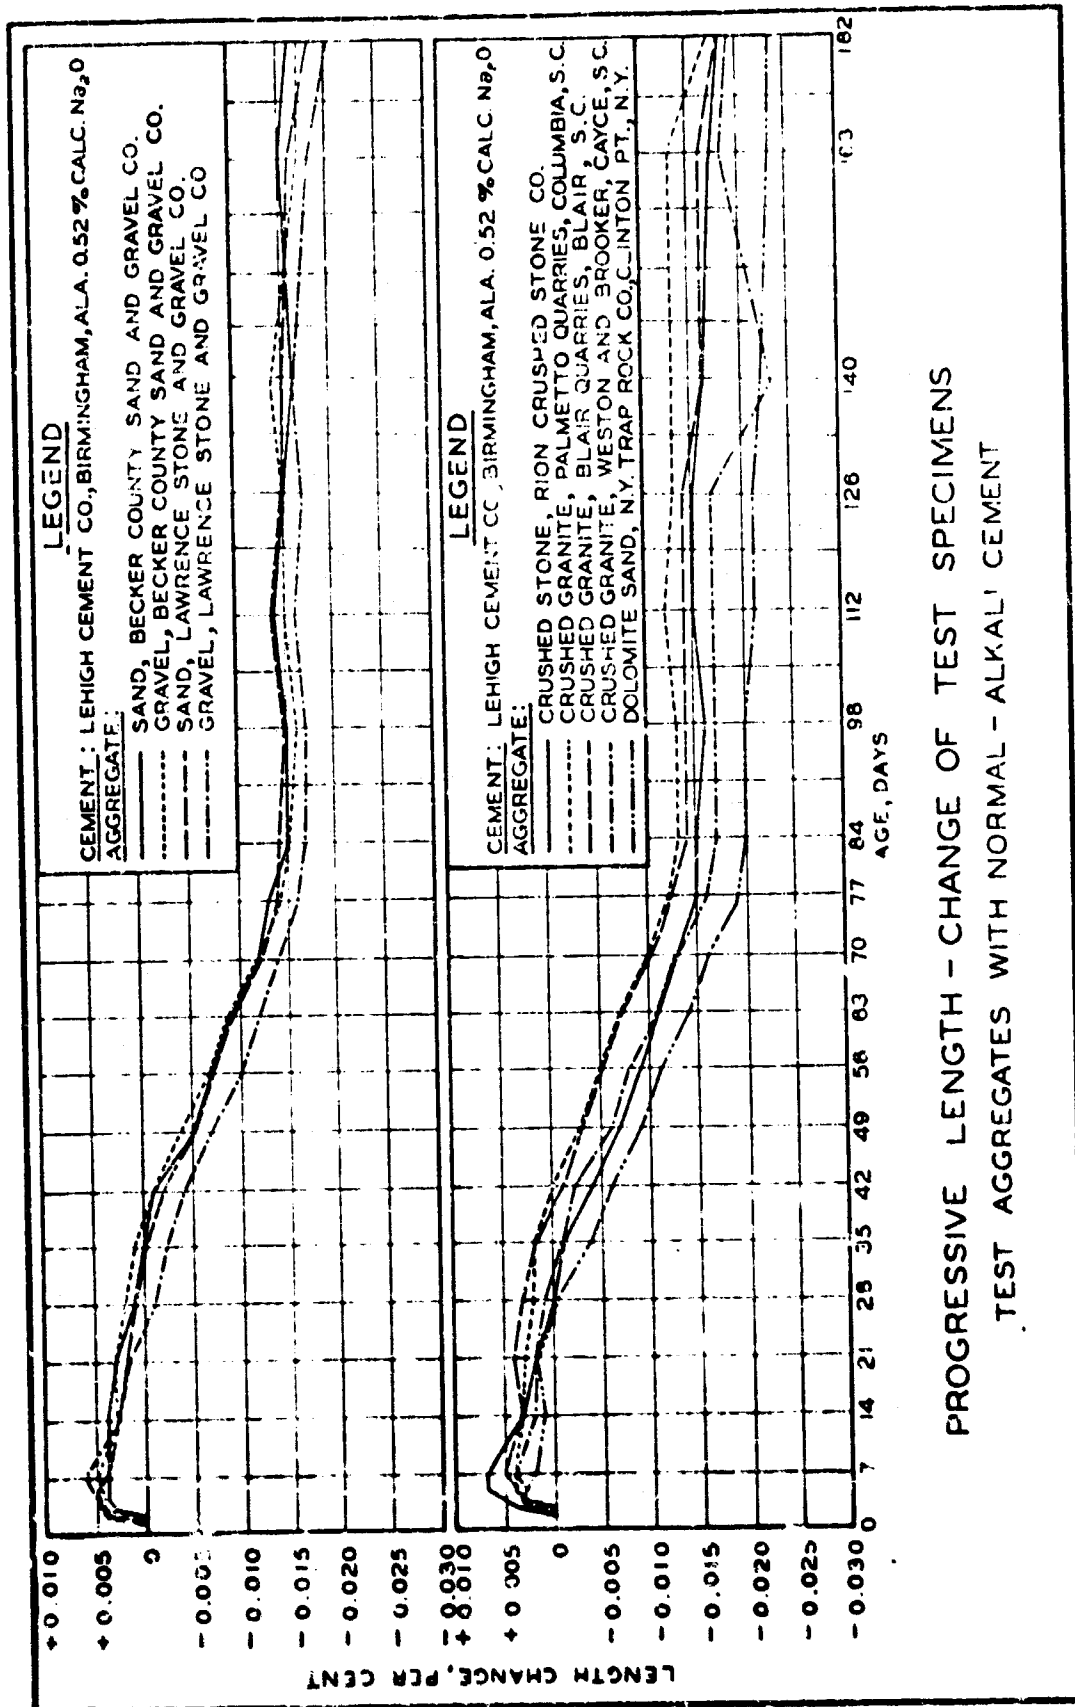
19. The average values for length-change of each group of three bars and of the three rounds of similar bars at each age are given in table 4. The average values for each test condition are plotted in plates 1-3.
